## PIC32MX534/564/664/764 Family Silicon Errata and Data Sheet Clarification

The PIC32MX534/564/664/764 family devices that you have received conform functionally to the current Device Data Sheet (DS61156G), except for the anomalies described in this document.

# PIC32MX534/564/664/764

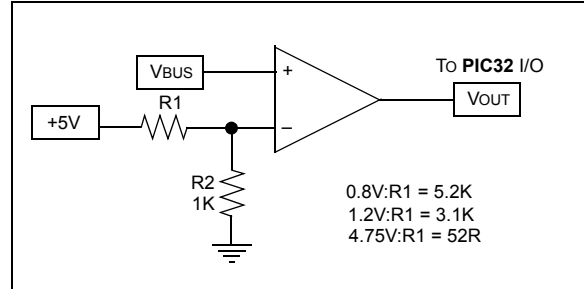
**FIGURE 1: EXTERNAL COMPARATOR SCHEMATIC EXAMPLE**

When the USB model is configured for OTG operation, it may not properly recognize all required OTG voltage levels on VBUS pin.

Use external comparator circuit to detect OTG specific voltage levels on VBUS pin.
